# CONDENSTOP® GETS A GRIP ON CONDENSATION

## **CONDENSTOP®** *Helps fighting corrosion*

**DC2116/1**  
**Cyclic Corrosion Testing of the**  
**Condenstop Product**

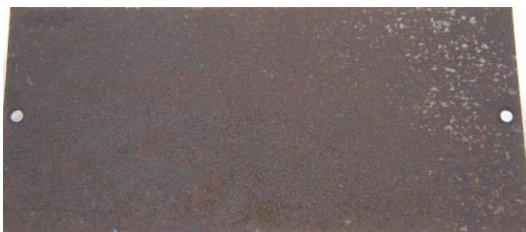
Figure 2. Salt coated steel sample after 500 cycles.

After 250 cycles, the non-covered steel samples showed several small red rust spots on the surface. The steel samples that were covered with CONDENSTOP® showed no visible changes. As expected, the salt coated steel samples showed significant acceleration of steel deterioration; they were heavily corroded and covered with thick, red-brown, iron-rich rust; the salt coated steel sheets covered with CONDENSTOP® however clearly showed significantly less deterioration than the non covered steel samples.

After 500 cycles, the non-covered steel samples showed relative large red iron-rich rust spots, viewing under the optical microscopic further revealed many very small rust-like features. These typical corrosion characteristics were rarely observed on the steel samples covered with CONDENSTOP®. The salt coated steel samples directly exposed to the lab atmosphere were heavily corroded as shown in figure 2; the surface morphology of the mild steel sample showed that red-brown, iron-rich, rust covered the whole surface. The salt coated steel samples covered with CONDENSTOP® however, while also corroded, showed significantly less oxidization than the bare samples, as shown in figure 3.
