Condensation In Metal Buildings

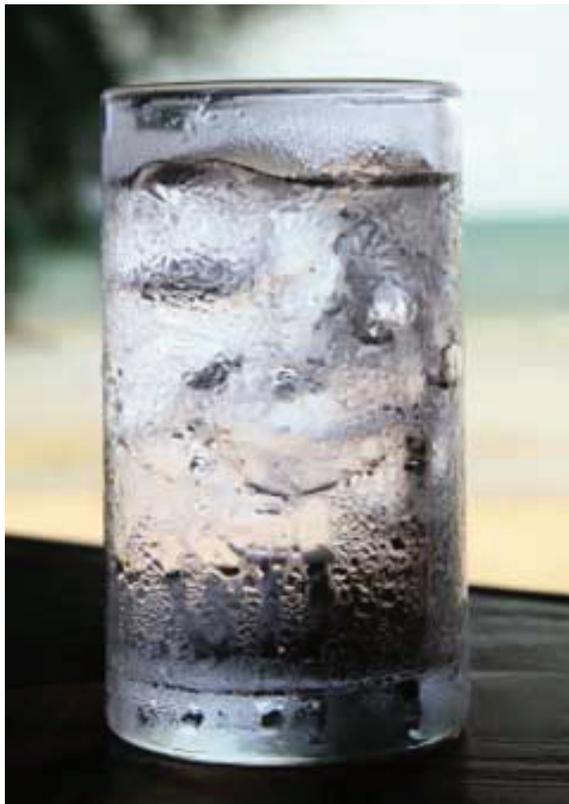
Condensation occurs at cold surface areas. Cold transfers through metal that is exposed to outside

Droplets form on the Warm Air Side

temperatures and forms on the warm air side. An example of this is a water glass with ice. The outside of the glass can become wet as the condensation forms on the warm air side. Visible condensation can be controlled by reducing the cold surface areas.

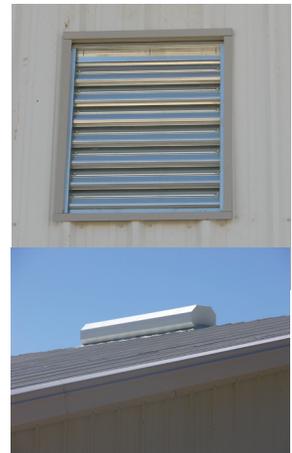
In cases where a metal building is insulated from the underside of the existing roof deck there is very little if no area to ventilate above the insulation. In these cases, the insulation blankets should come in contact with the outside panel, filling the cavity and not leaving any room for airspace. The area below the insulation can be ventilated by mixing outside air with inside moist air. There are several indoor variables that put out an extremely high content of moisture, making ventilation crucial such as job site space heaters or livestock. In horse facilities, each horse perspires approximately (2) gallons of moisture into the air each day. This does not include the moisture in the air from urine or other factors. Without ventilation or air exchanges, moisture will collect on the roof and create a moist environment which can lead to respiratory ailments and fungal

growth. A good barn building design has enough ventilation to ensure six to eight air changes per hour.

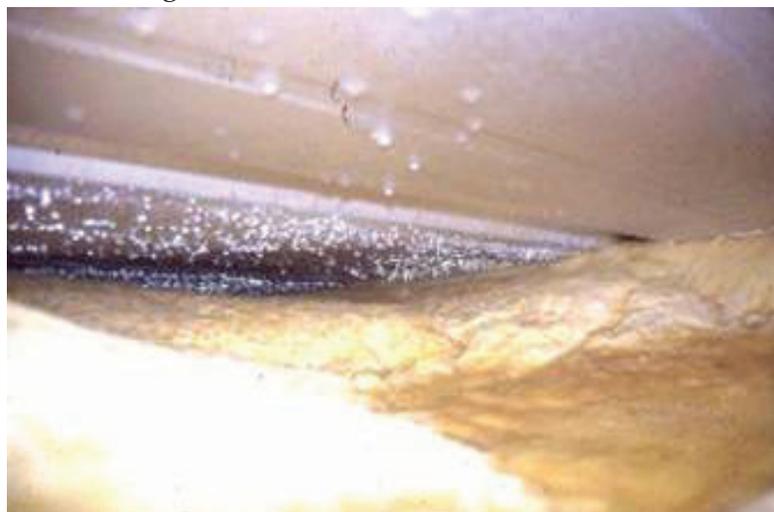
Condensation formed on underside of exterior panel b/c the entire cavity was not filled with fiberglass insulation.

Concealed condensation is one of the most difficult and damaging types of condensation. Typically, concealed condensation occurs on the underside of the steel roof deck when the roof insulation is not in contact with the roof panel, causing trapped warm air to come in contact with the outer panel. When we see concealed condensation we often find that the facing or vapor retarder is not sealed properly for the moisture levels and the ventilation is not adequate in the building.

Typically, structural members (roof purlins or wall girts) are 8" deep. It is recommended in retro fit jobs that the entire 8" cavity is filled with insulation to avoid creating an air space between the roof panel and insulation. This is important because air spaces can cause condensation to frequently form on the inside of the cold surface of the exterior panel.

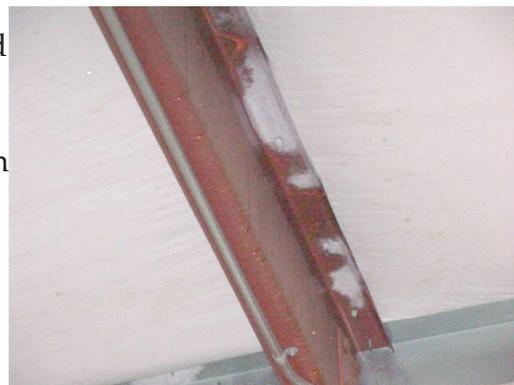
Frost buildup on purlins

Condensation issues are more difficult to address in cases where there is no insulation previously installed between the outside panels and structural members. This is because there is no thermal break between structural members and the outside panels making it easy for cold to transfer from one metal to another, eventually making it into the building. Once the cavities between the purlins are filled with faced fiberglass and heat is introduced into the building, condensation or frost can still form at the bottom of the structural members. To help avoid this, a thermal break tape or strips of rigid board insulation can be installed at the bottom of the purlin or girt.

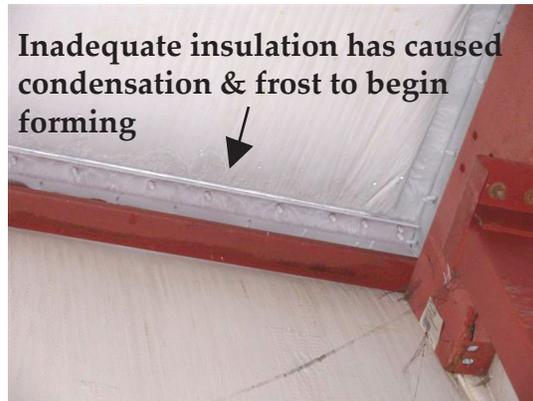
Metal building insulation offers several different options. Care should be taken to seal the vapor retarder facings and or provide a continuous

covering such as polypropylene to help prevent the passage of vapor into the fiberglass blankets. A continuous vapor barrier will help prevent moisture from working its way into the fiberglass. It is also important to provide a thermal break at each roof purlin or wall girt to prevent heat or cold transfer. Thermal breaks are achieved by either laying insulation over the top of the girts and or purlins before the panels are screwed down; with 1/4" Thermal Break Tape; or with 1/2" or 1" Thermal Blocks.

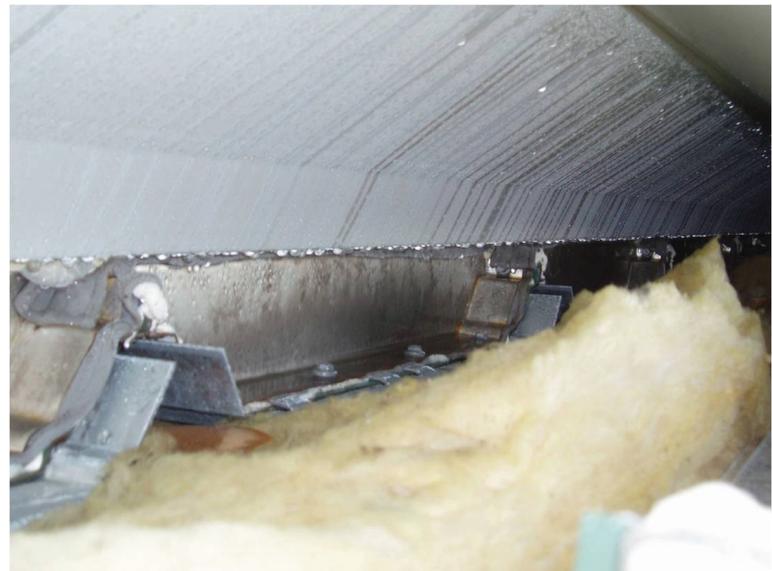
Cold transferred through the metal and formed condensation on the warm air side.
